RENAISSANCE

Specialists in Exterior Masonry & Historic Preservation

Tuckpointing

GENERAL INFORMATION

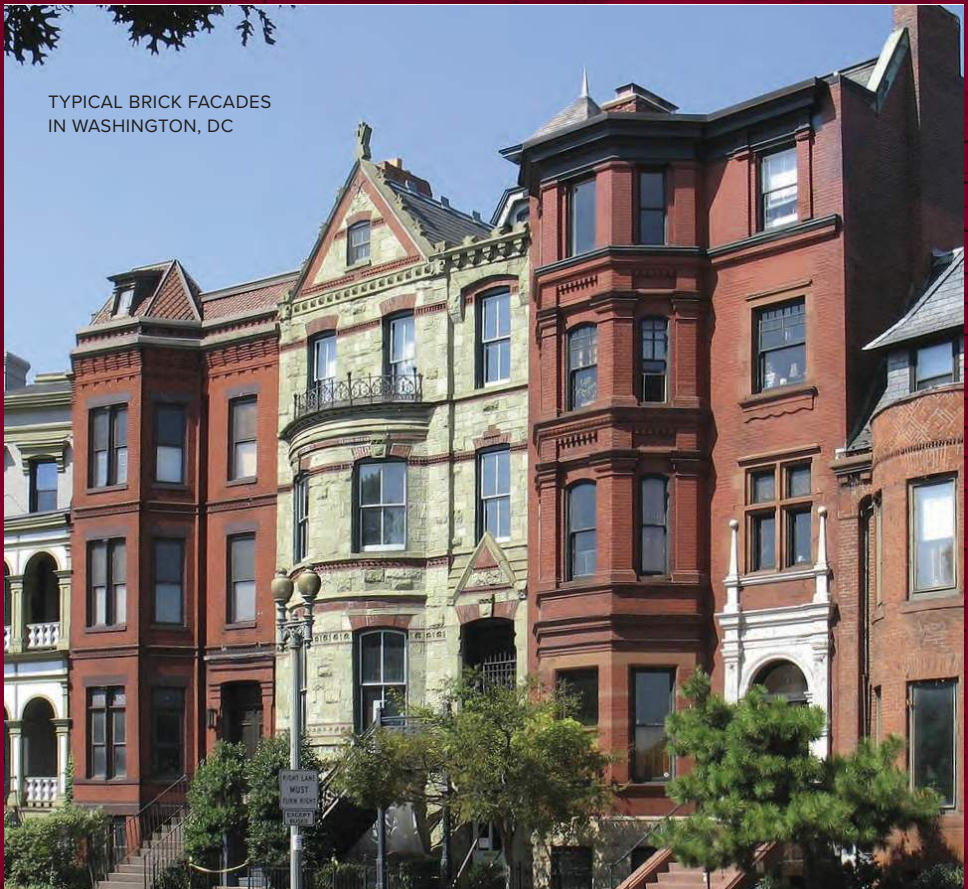
Most of the brick buildings in Washington, DC's historic neighborhoods show indications that they need tuckpointing. Their masonry joints contain powdery mortar that crumbles to the touch and is easily extracted with a key or pencil. These joints, which appear dark or shadowed, are recessed from the brick faces, allowing moisture to penetrate the walls. Eventually, brick courses will sag and buckle, indicating significant structural failure that will worsen exponentially over time.

TYPICAL BRICK FACADES
IN WASHINGTON, DC

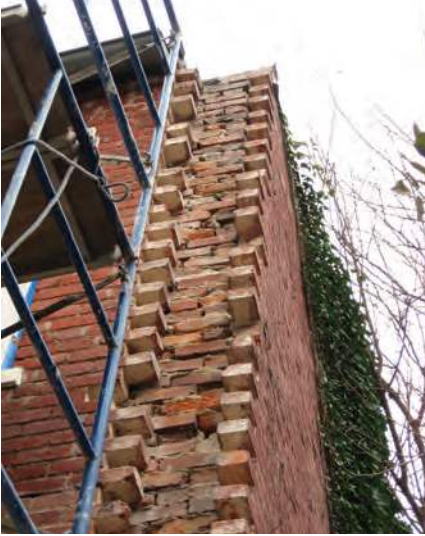
Tuckpointing—or repointing—describes the restoration and preservation of brick buildings by removing the deteriorated mortar between masonry joints and replacing it with lime-based mortar. If done correctly, tuckpointing will ensure the structural integrity, longevity, and value of historic masonry buildings.

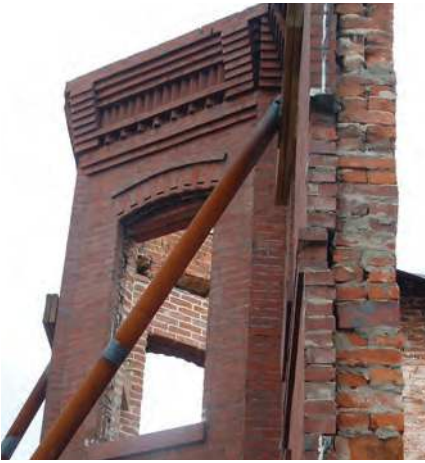
Limestone, a material used in construction for centuries, is burned in a kiln into a smoldering powder [much like lighted charcoal briquettes]. This substance, combined with sand, crushed shells, horse hair, and other natural materials produces mortar. The resulting “hot mix” was placed below, on top of, and between bricks to form buildings large and small.

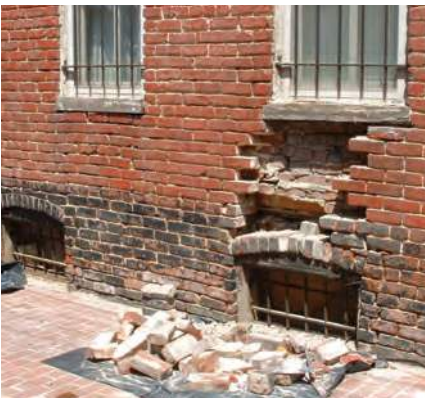
Brick structures in Washington, DC built from the 1700s until the 1920s have load bearing walls consisting only of bricks and mortar. They generally contain no iron, steel, or any other reinforcing structural support. These load bearing buildings—meaning that their own weight provides structural integrity—were built of coal-fired clay bricks assembled with lime-based mortar.

PARTIALLY DEMOLISHED LOAD BEARING BRICK WALLS

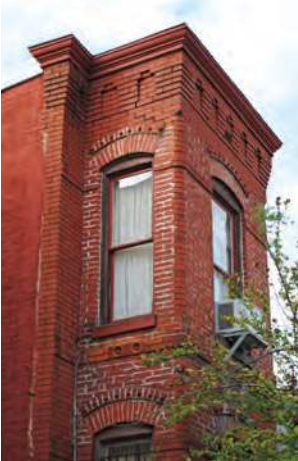
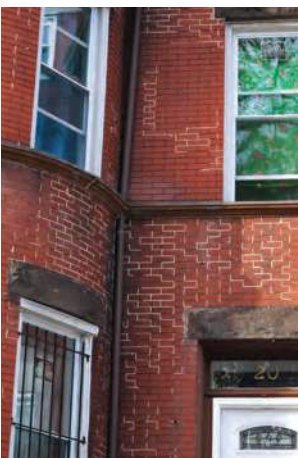
If a historic building is not tuckpointed properly, it will show signs of structural damage and water penetration. These problems are most readily apparent around door and window openings, but can occur anywhere on a brick façade.

Mortar failure is easily recognizable at a building’s ground level. After running down the walls from the roofline, precipitation stains the brick walls [often with black or green mold] and penetrates the mortar joints.

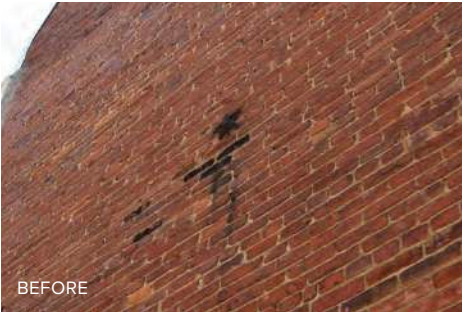
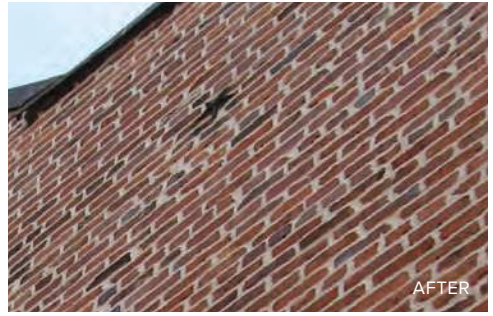
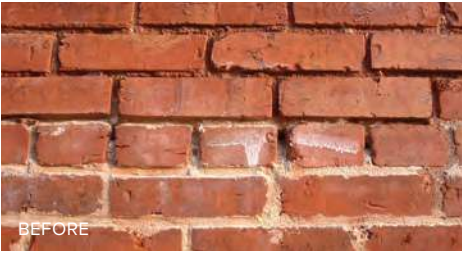
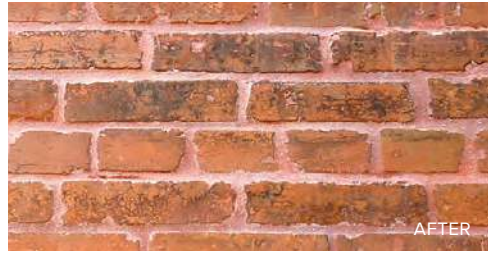
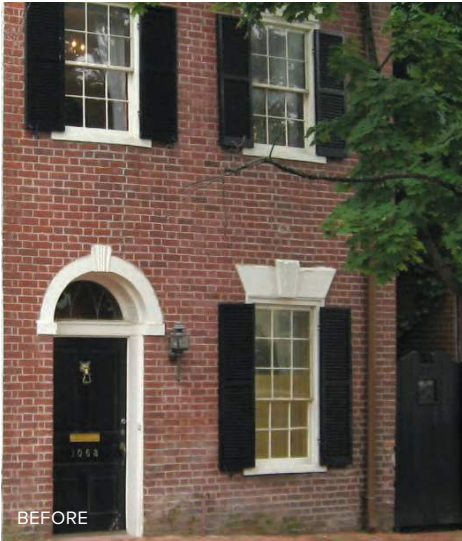
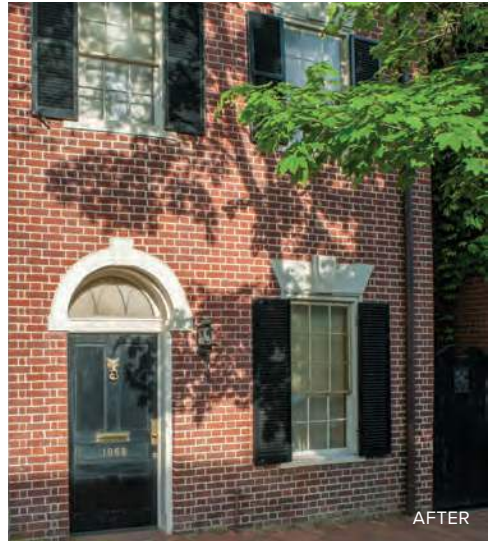
Some consider “spot tuckpointing”—filling holes with cement only where damage is most apparent—a reasonable repair, especially because it is quick and inexpensive. Although this practice is visible all over Washington, spot tuckpointing is merely a stopgap approach that can neither stabilize a building nor halt its deterioration.

**SPOT TUCKPOINTING
USING CEMENT**

Although cement—the key ingredient in concrete—fueled America’s booming postwar economy, revolutionized the building industry, and is common in new construction, its use on historic buildings is both inappropriate and detrimental. If a pre-World War II brick building is tuckpointed with cement, that material’s extreme density [its level of hardness] will cause the softer coal-fired bricks to crack.

In addition, the acidic chemicals in cement are incompatible with both the molecular structure of both historic bricks and lime-based mortar. Removing cement from old brick joints reveals severely compromised lime mortar underneath, which is always in worse condition than if the joint had never been improperly repaired.

Since cement repairs deteriorate lime mortar, the resulting gap between the cement and lime also allows water to work its way into the wall. Evidence of water damage on interior walls, however, does not necessarily correspond to the same location on the building’s exterior.

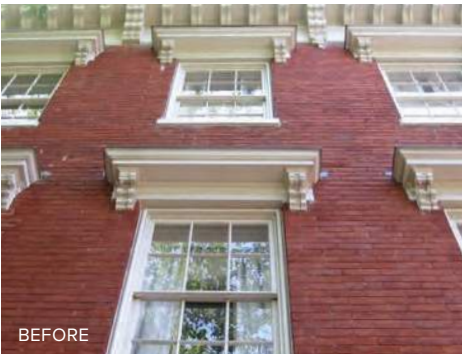
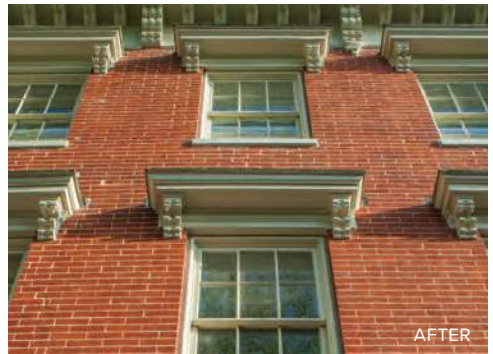
TUCKPOINTING PROJECTS COMPLETED BY RENAISSANCE DEVELOPMENT.
